The Tale of the Blasting at Cape Horn

(Reprinted from the "Steward's Scene," newsletter of the Pacific Northwest River Basins Commission, February-March, 1978.)

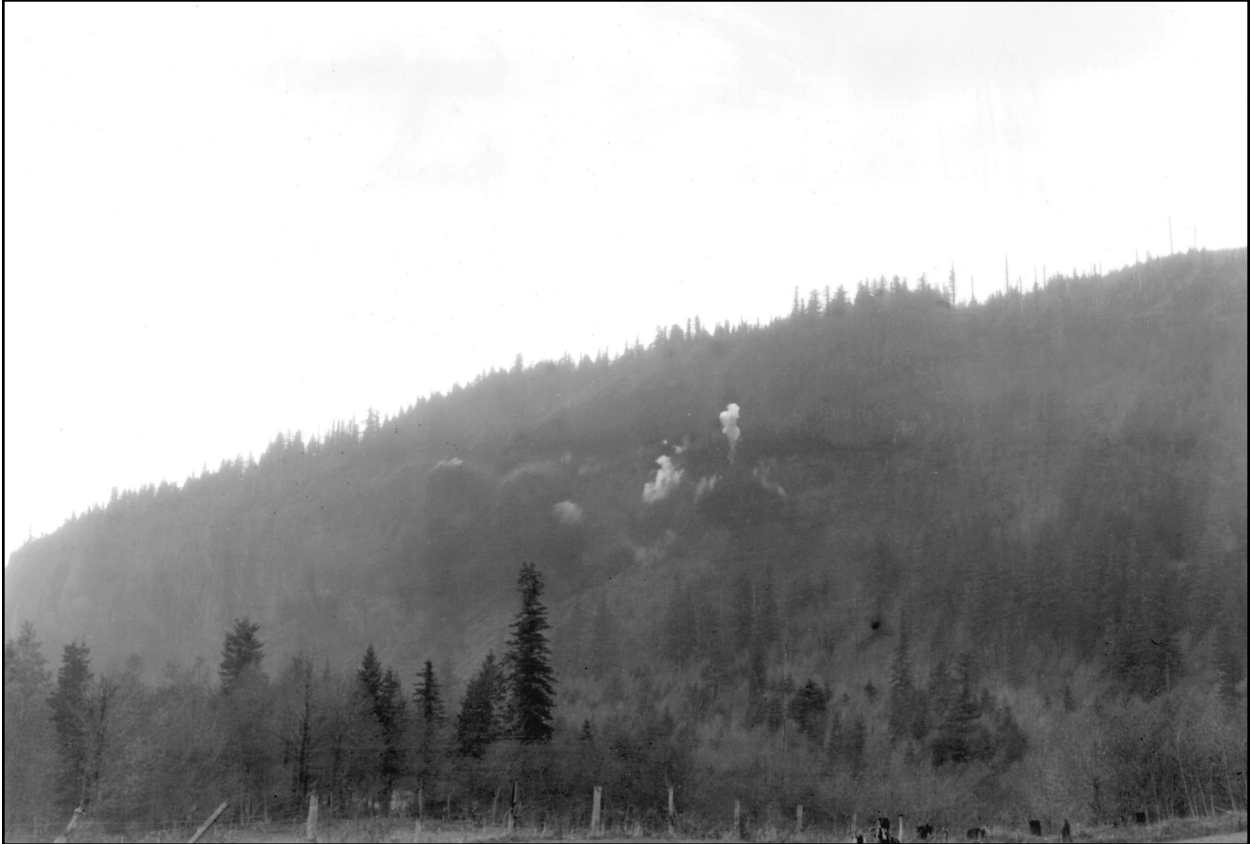
Puff of smoke goes up when the dynamite went off and the rock came tumbling down at Cape Horn.

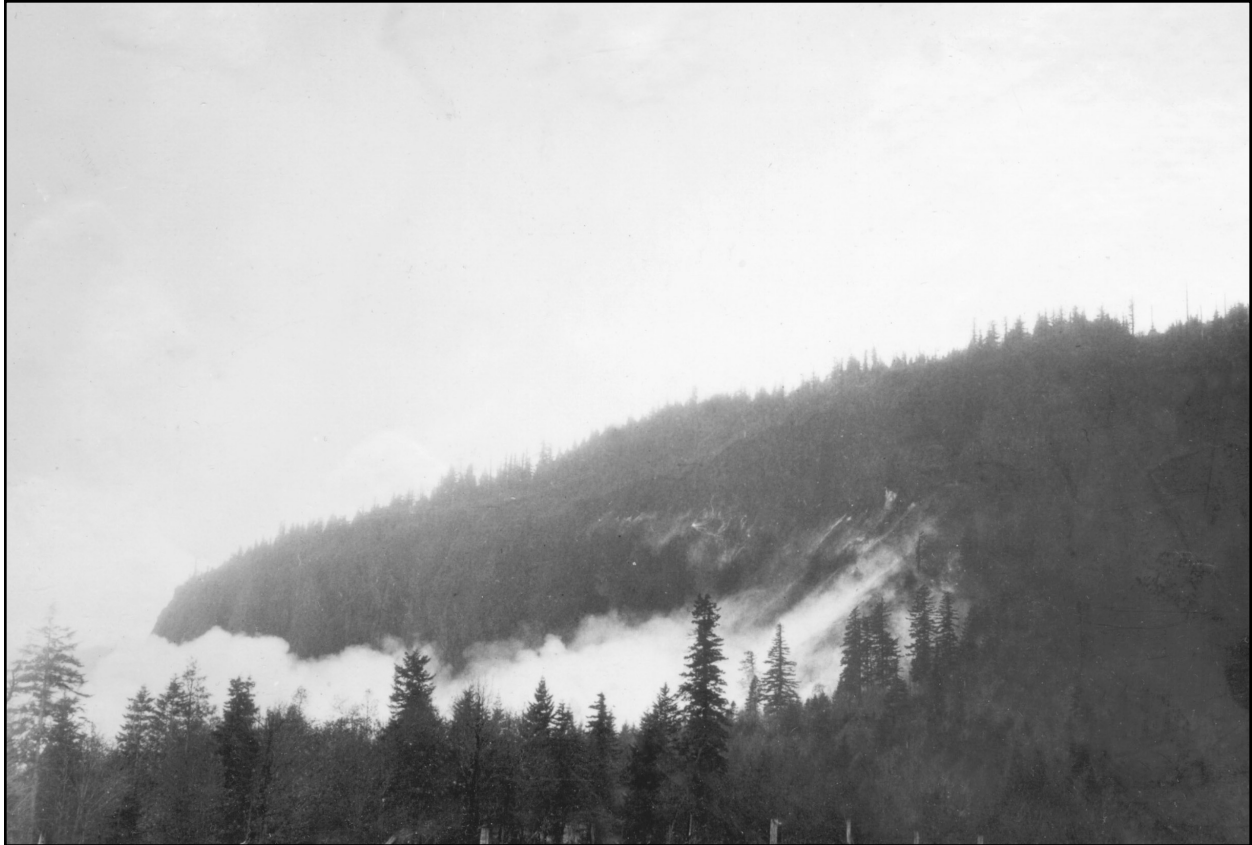
Puff of smoke goes up when the dynamite went off and the rock came tumbling down at Cape Horn.
